Water Erosion Experiment Update

T.Davenne, O.Caretta and the HPTG

PASI meeting at RAL 9th Sep 2014

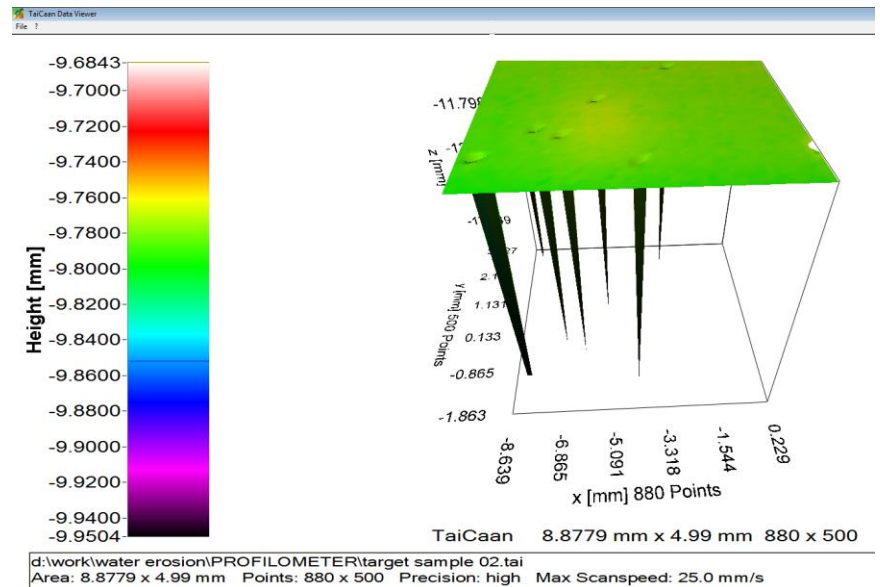
Analysis of the tungsten sample
Shows several pits

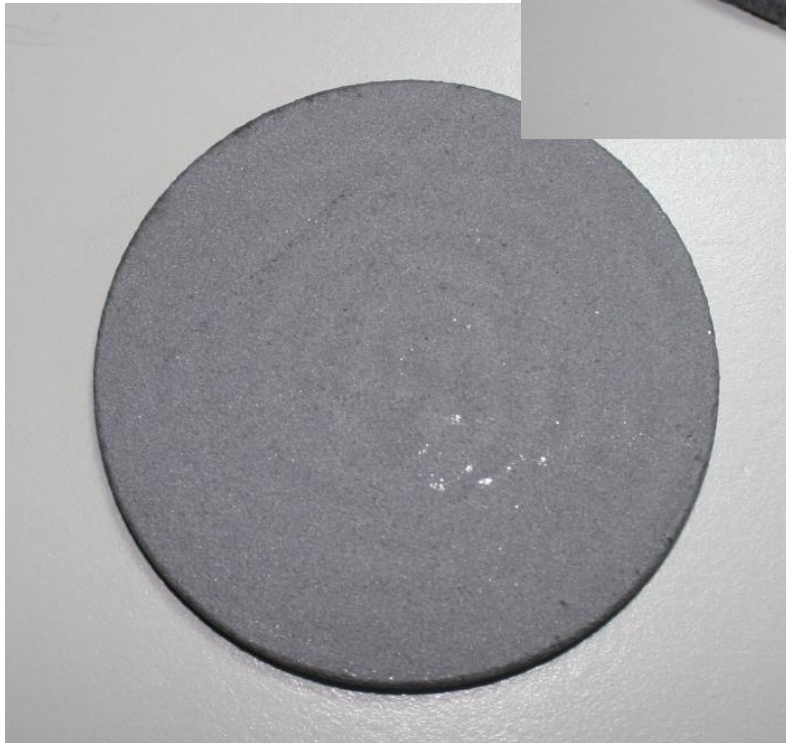
Cold sprayed tantalum

Plastically deformed Ta beads
(this is not a real picture)

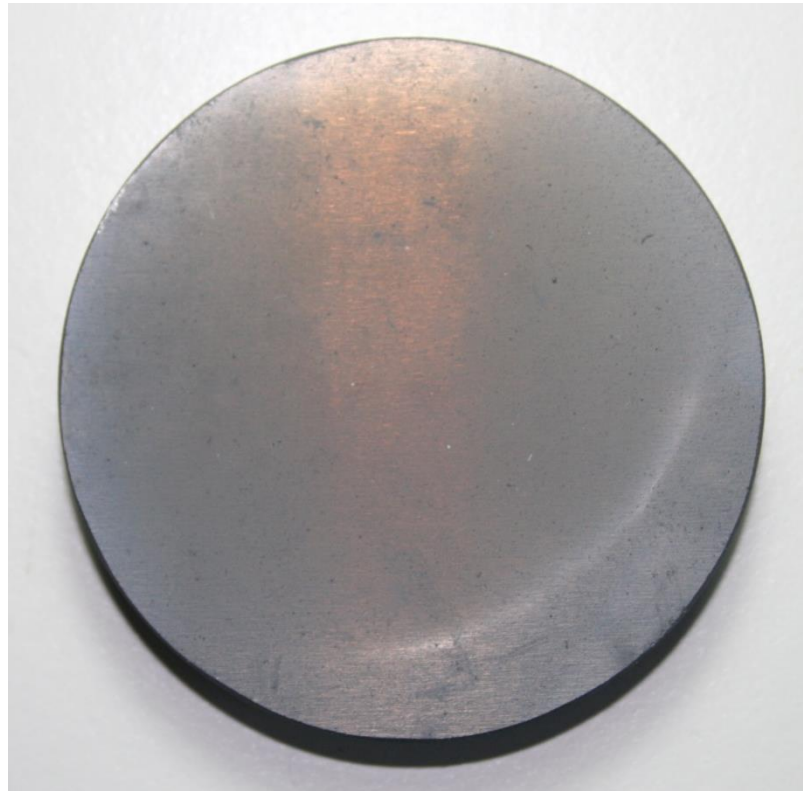
SiC Chemical Vapour
Deposition CVD
